Hydrogeology of the West Bench Aquifer

Beartooth Front Community Forum Webinar, December 9, 2021

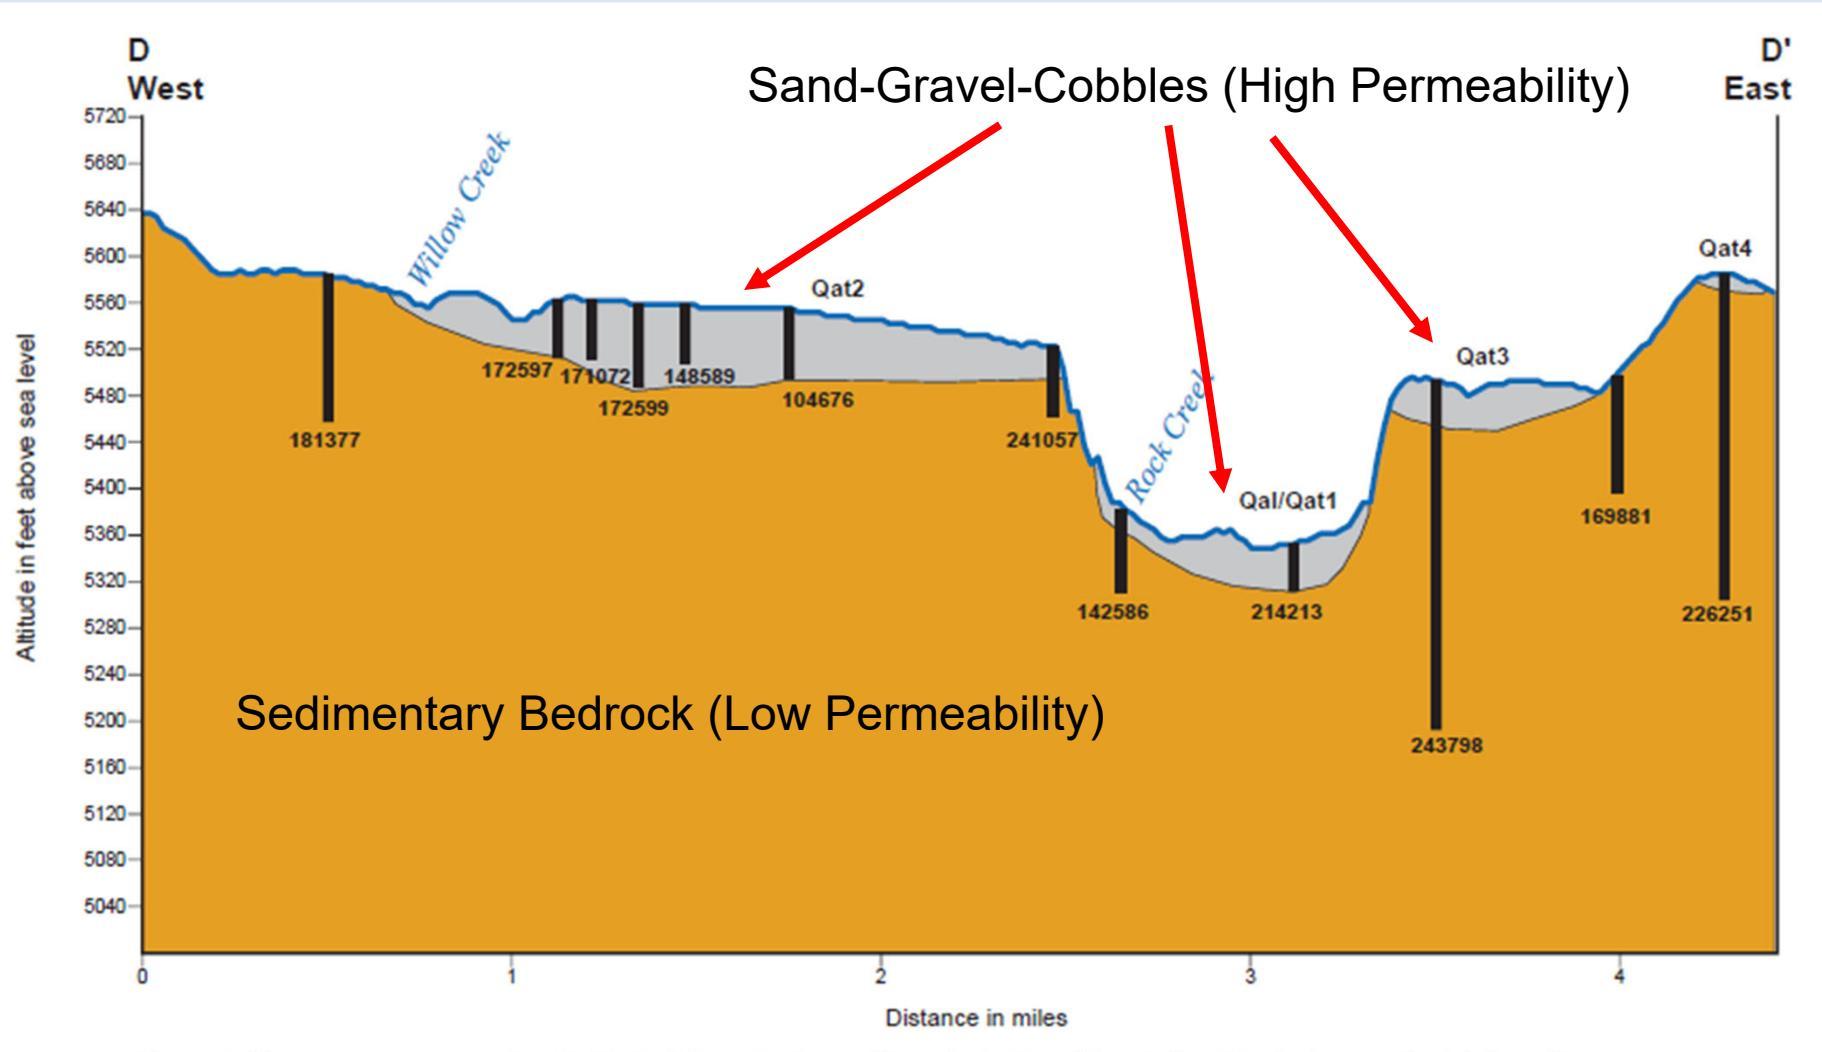
West to East Cross Section Near Red Lodge

Figure 8. Transverse cross-section D-D' depicting physiographic and stratigraphic relationships between alluvial deposits.

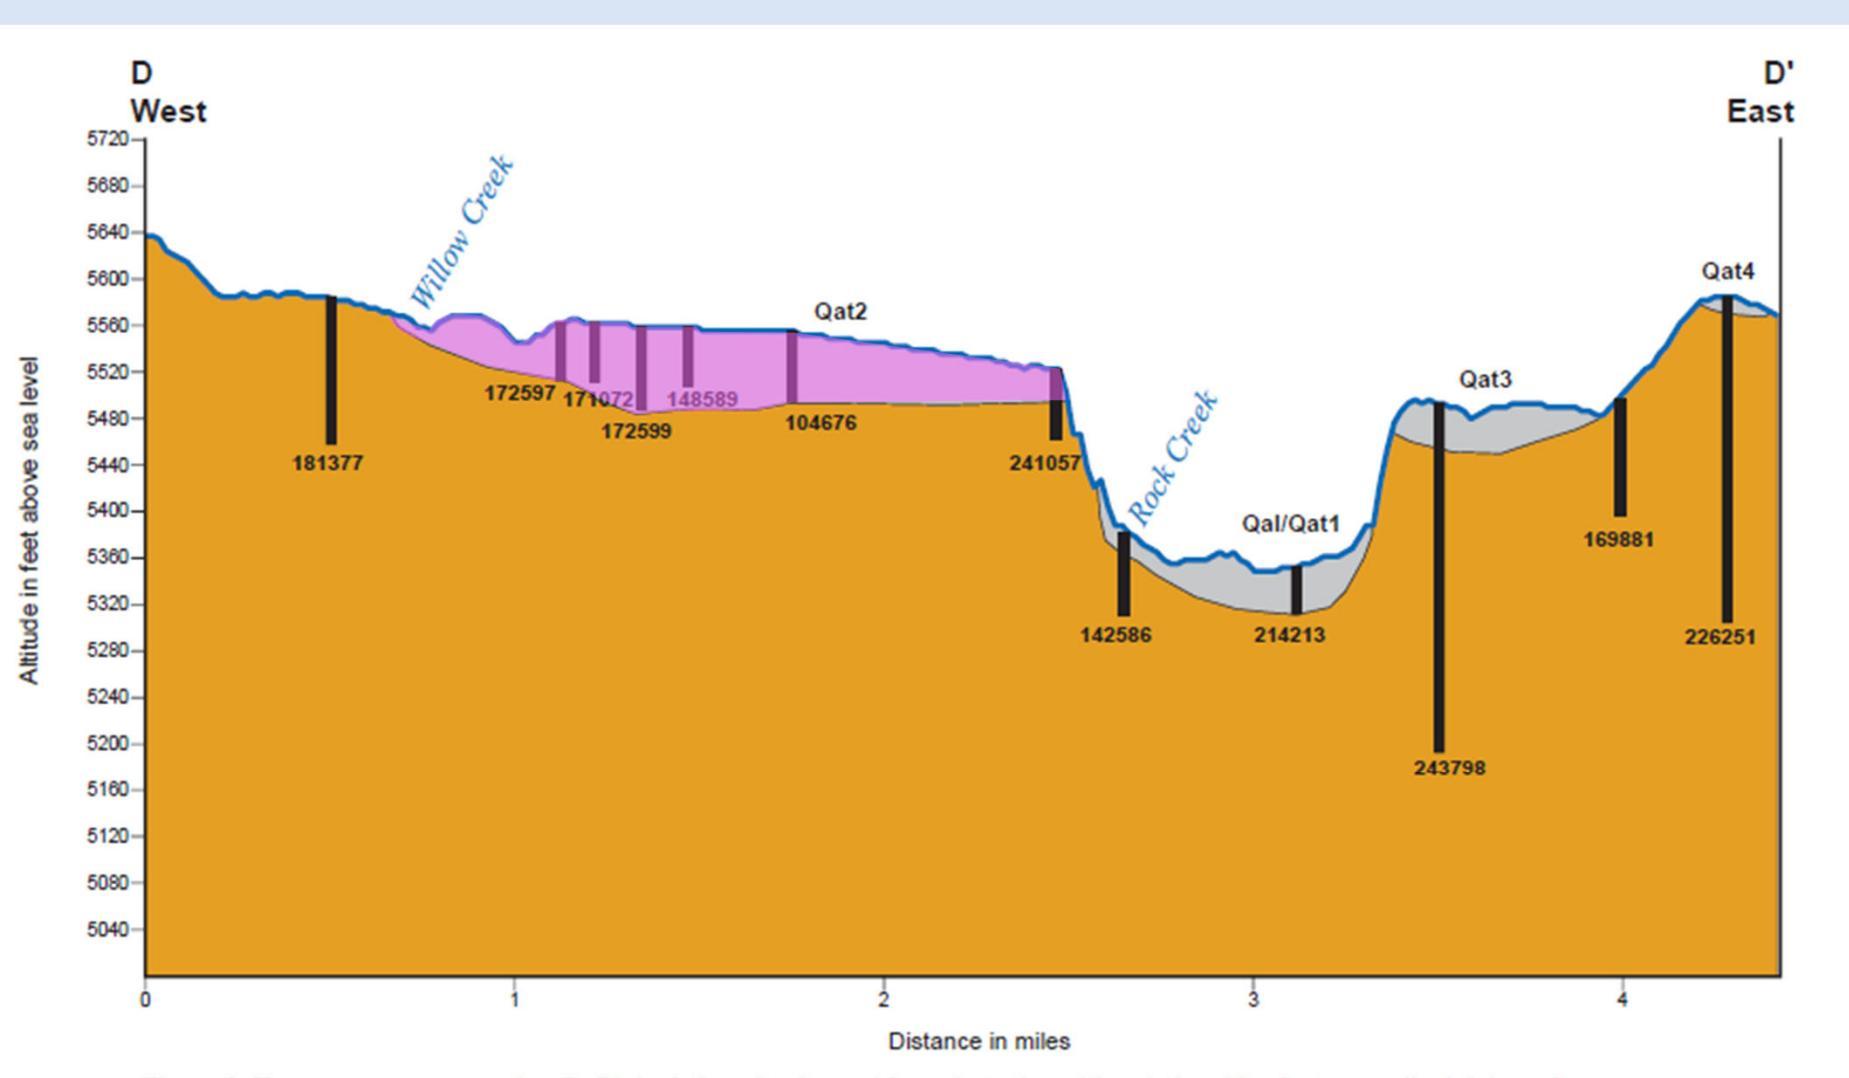
West Bench Aquifer

Figure 8. Transverse cross-section D–D' depicting physiographic and stratigraphic relationships between alluvial deposits.

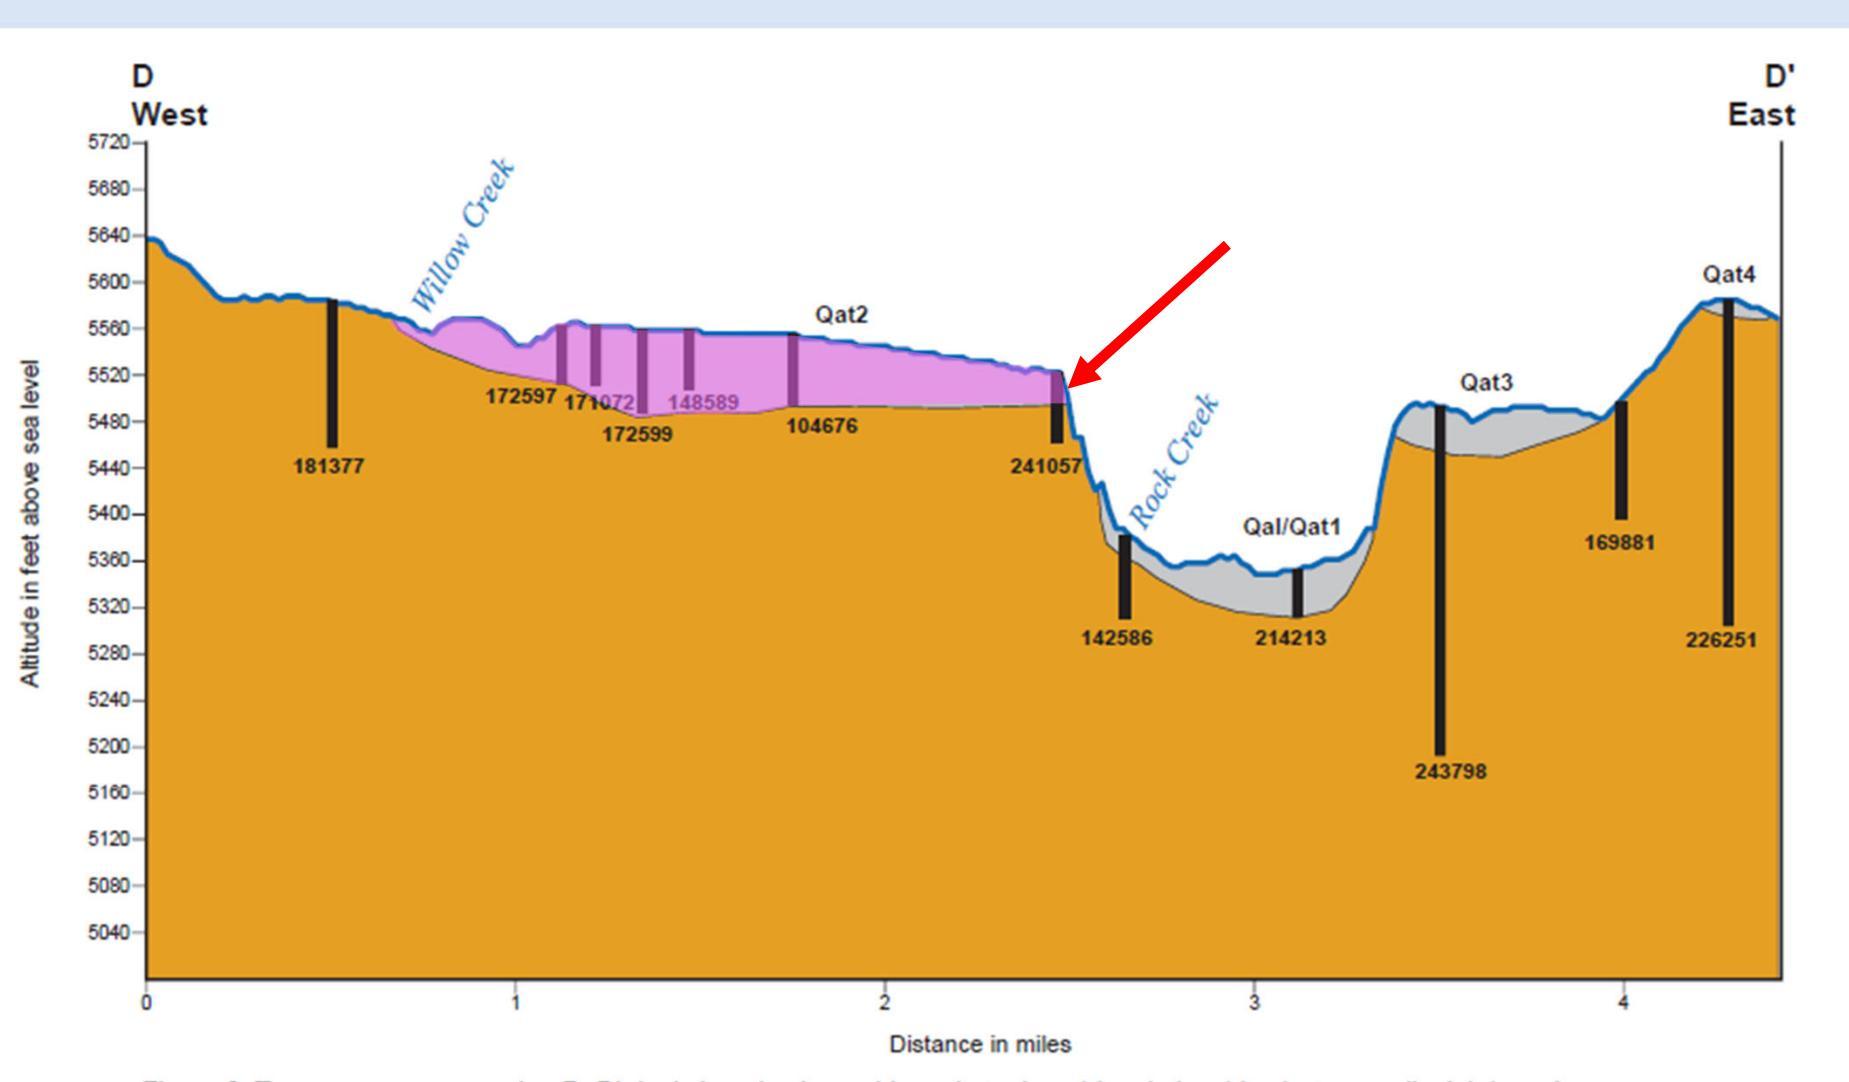
West Bench Aquifer

Figure 8. Transverse cross-section D–D' depicting physiographic and stratigraphic relationships between alluvial deposits.

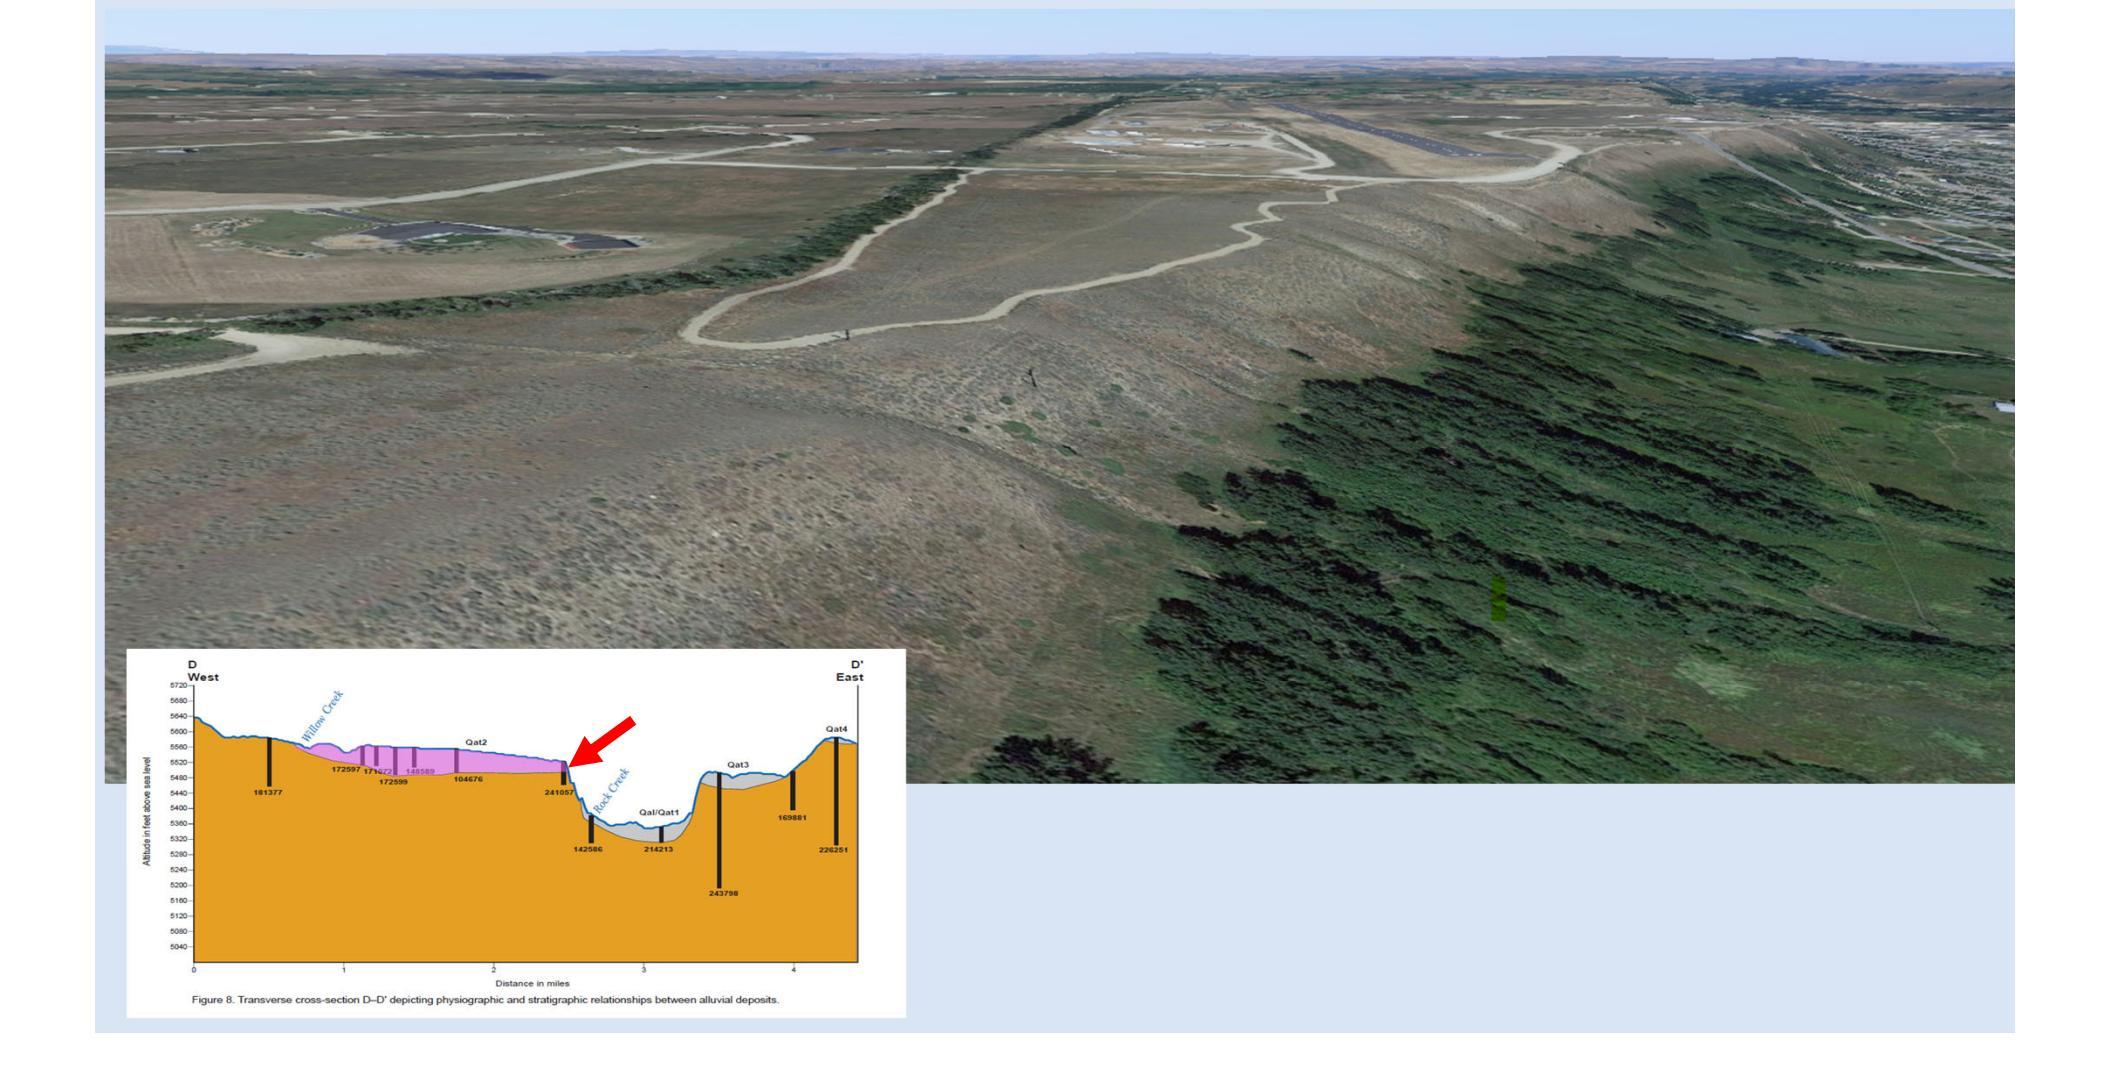
"Green Line" showing Groundwater Discharge from West Bench Aquifer near the Airport

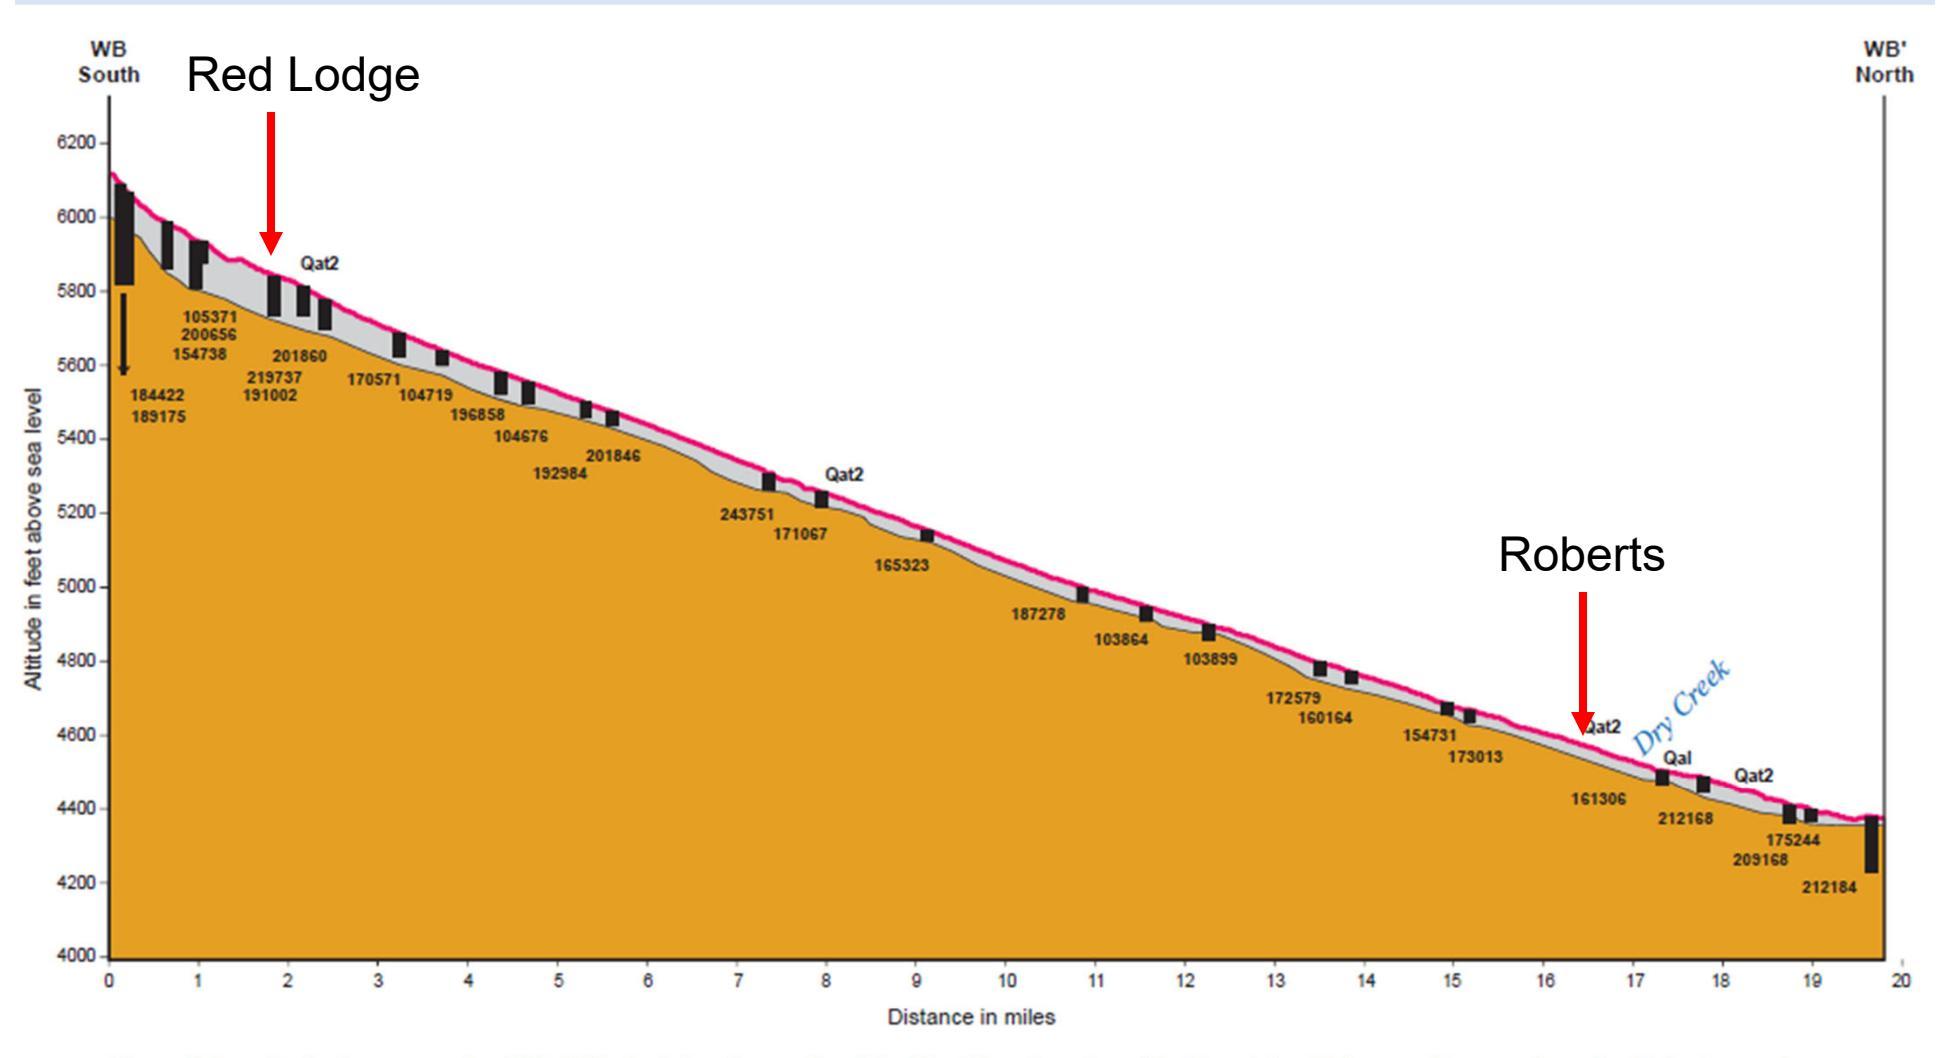
South to North Cross Section Red Lodge to Roberts

Figure 2. Longitudinal cross-section WB–WB', depicting the profile of the West Bench surface (Qat2) and the thickness of terrace deposits. Note decreasing thickness of the terrace deposits to the north. Source: Reiten, 2020

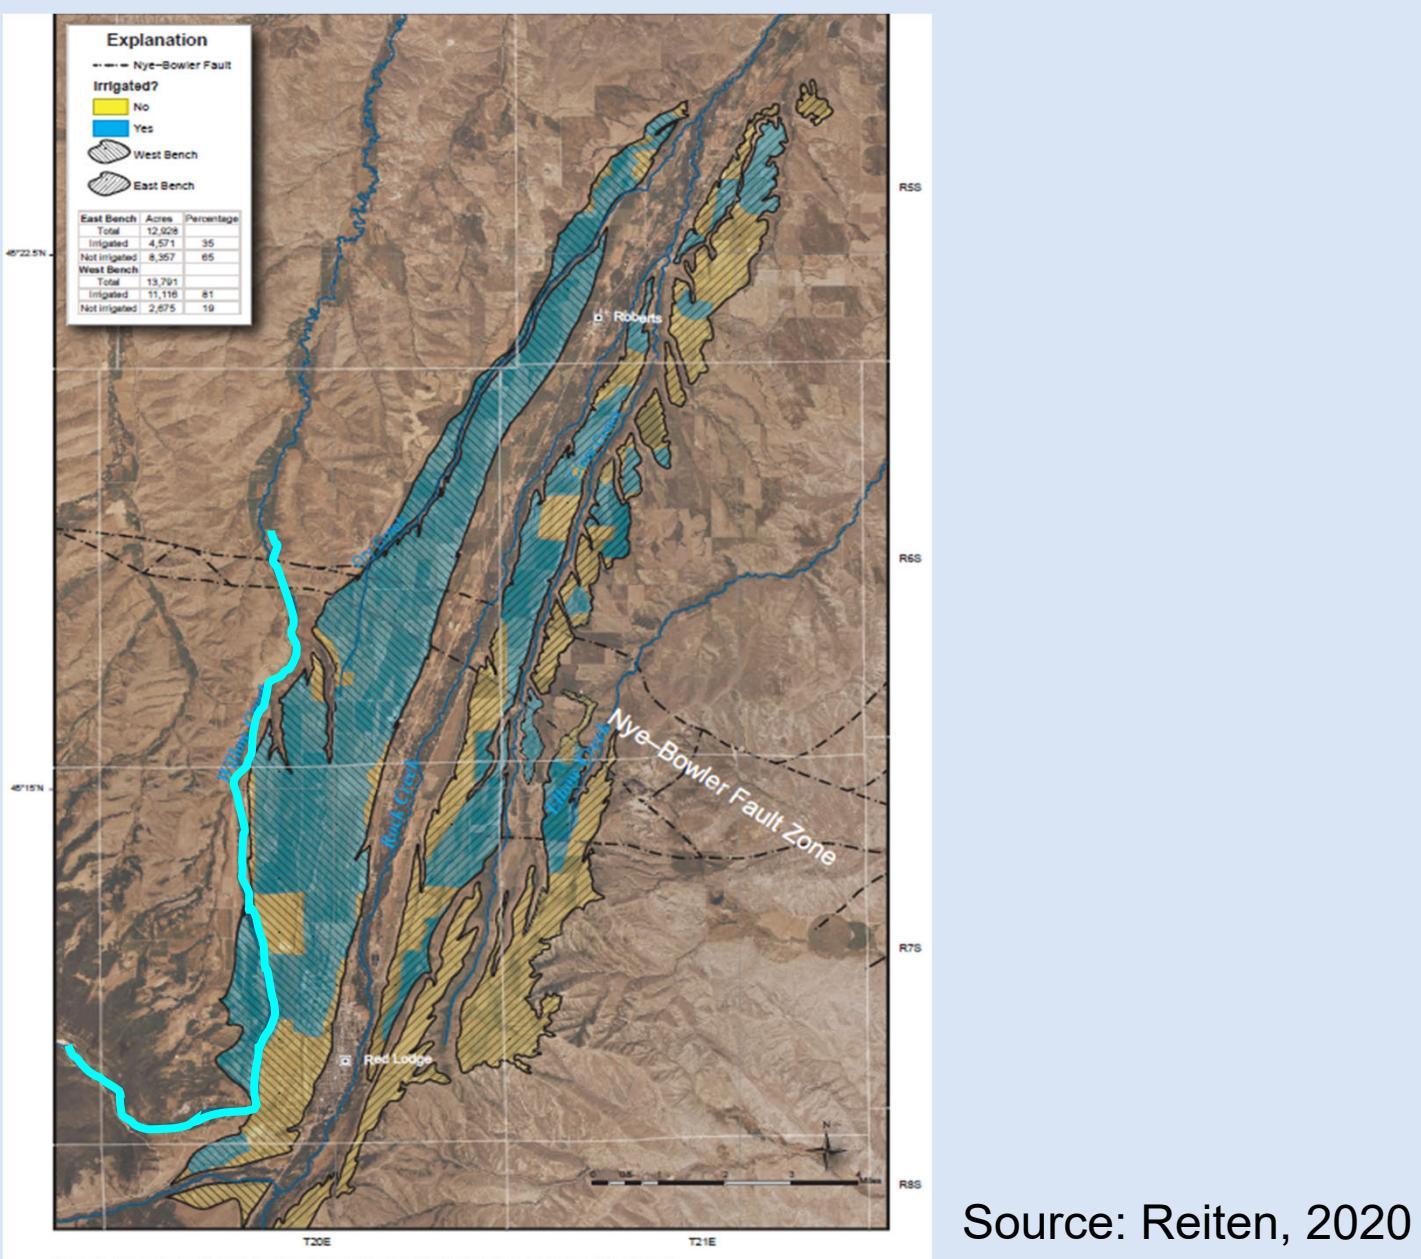
Figure 3. Comparison of Irrigated and non-Irrigated land on the East and West Benches of Rock Creek.

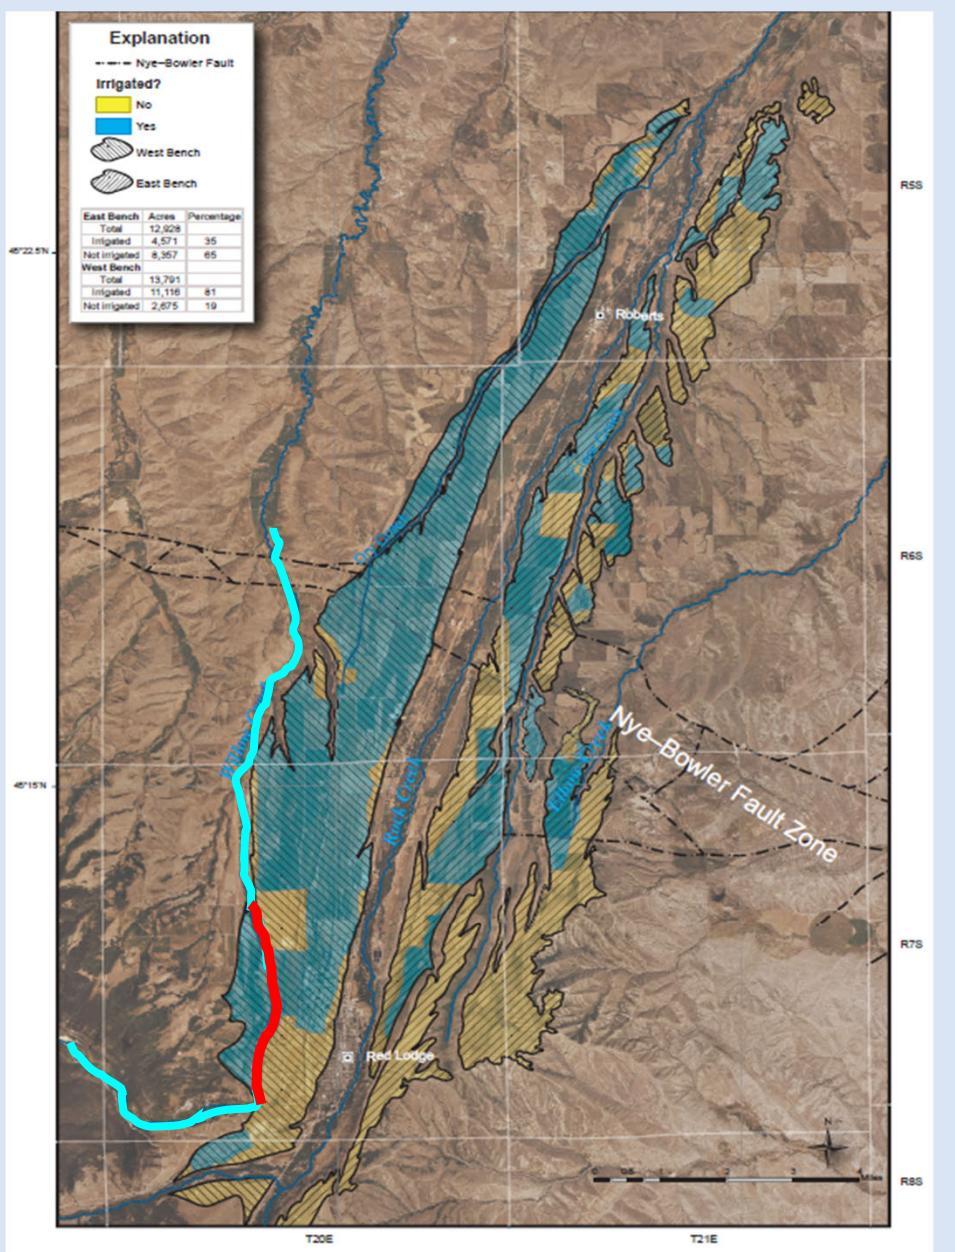
~ 4 miles of Willow Creek

Figure 3. Comparison of irrigated and non-irrigated land on the East and West Benches of Rock Creek.

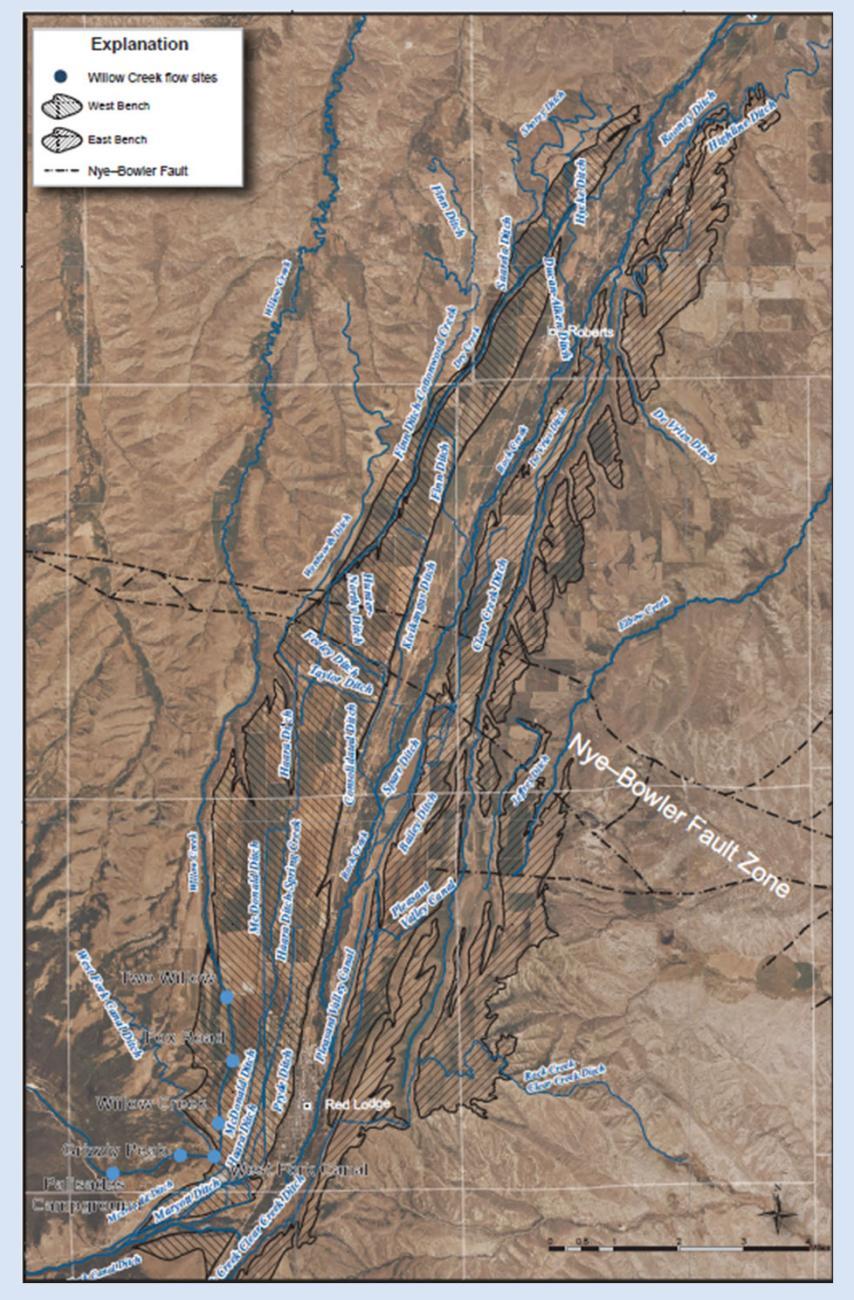
Man-made Surface Water

>40 miles of Irrigation Canals on West Bench
